**PENNSYLVANIA
ID NO. PA.00706**

FURNACE CREEK DAM

**PHASE I INSPECTION REPORT
NATIONAL DAM INSPECTION PROGRAM**

June 1978

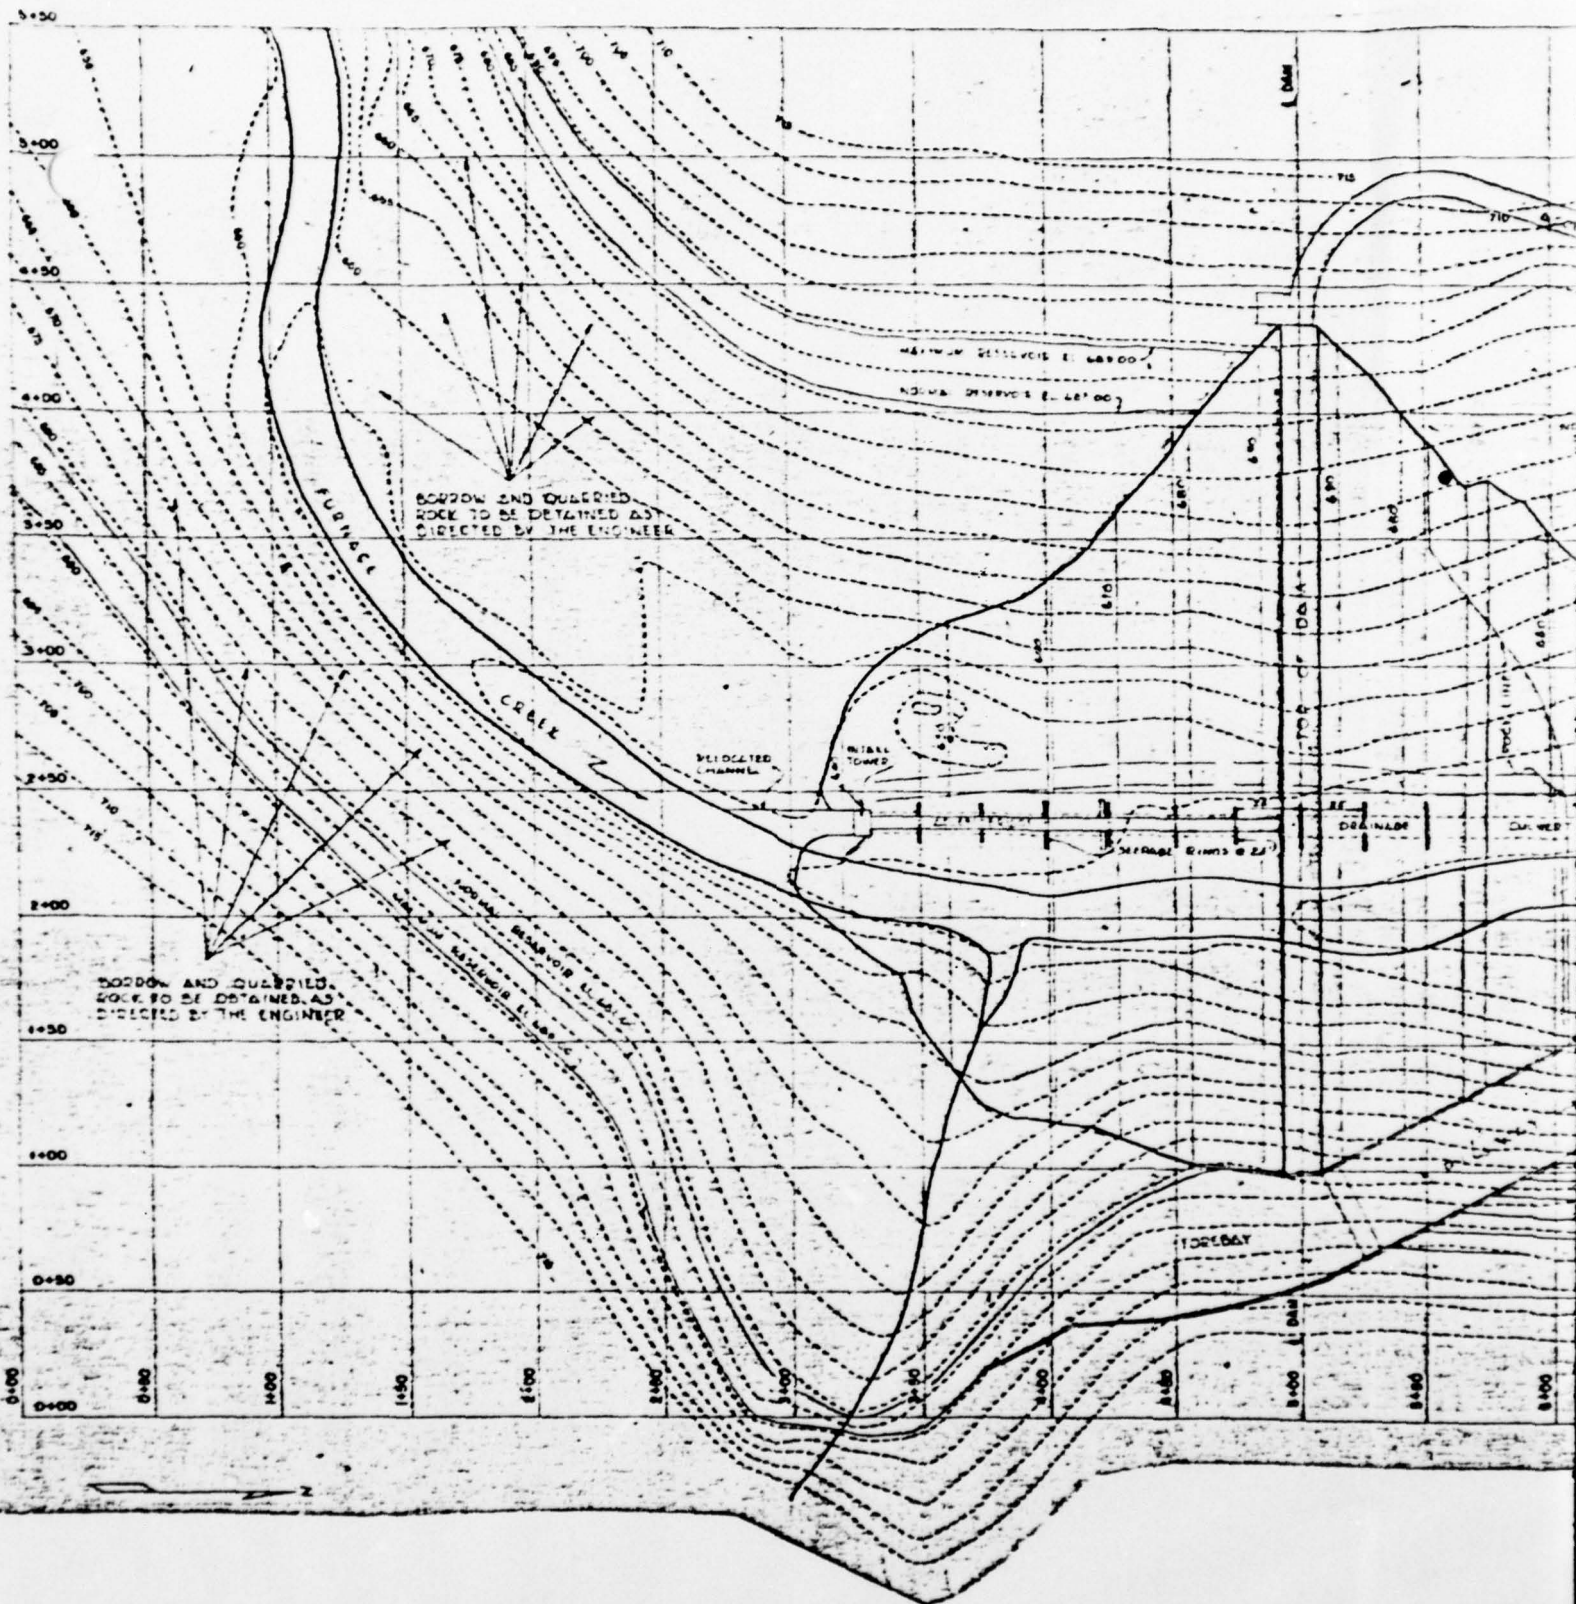
VISUAL EXAMINATION OF	OBSERVATIONS	REMARKS OR RECOMMENDATIONS
JUNCTION OF EMBANKMENT AND ABUTMENT, SPILLWAY AND DAM	Settlement of embankment/backfill observed at left spillway wall - 0.5' to 1.0' at dam crest. (See sheet 4, item 4 for explanation). Settlement as much as 1' at first buttress down from crest. (See Photo No. 8)	
ANY NOTICEABLE SEEPAGE	Clear water seepage at several locations. Seepage is ponded adjacent to left stilling basin wall with water level 3±' above water level in stilling basin. There are several seeps around discharge culvert and 20' to 30' to left of tunnel. Soft area and seepage at left abutment near valley bottom. Sources of seeps were obscured within rock toe. Volume of individual seeps estimated to be less than 5 gpm since no gauging is installed. Spring observed on access road about 300' from dam.	
STAFF GAGE AND RECORDER		
DRAINS	Water draining from stilling basin seep through weep hole in basin wall. (Seepage is clear). Relief drains in spillway slab on embankment side only.
